# Improving Personal Safety on Commuter Trains at Stations in the Republic of South Africa

## **Part 1:** Study of Platform Train Interface

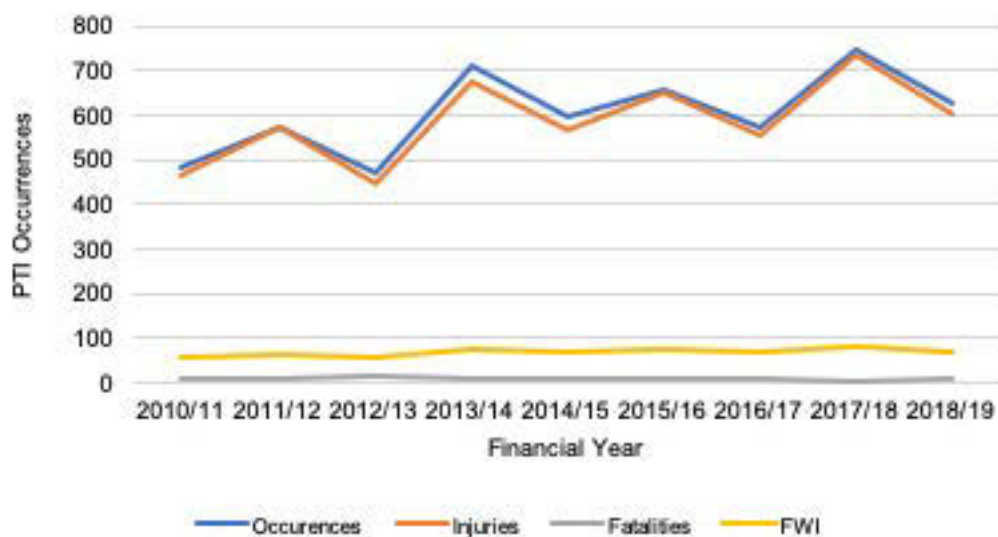
**Figure 2. Graph showing the number of PTI occurrences and related fatalities and injuries**

Figure 2 was adapted from the SoS Report 2018/19 and shows that PTI occurrences and injuries have been on the increase since the 2010/11 financial year. The number of deaths resulting from PTI occurrences have remained relatively stable (accounting for an average of nine fatalities per year) since 2010/11. This suggests that the challenge of PTI occurrences has not been managed effectively over the years.

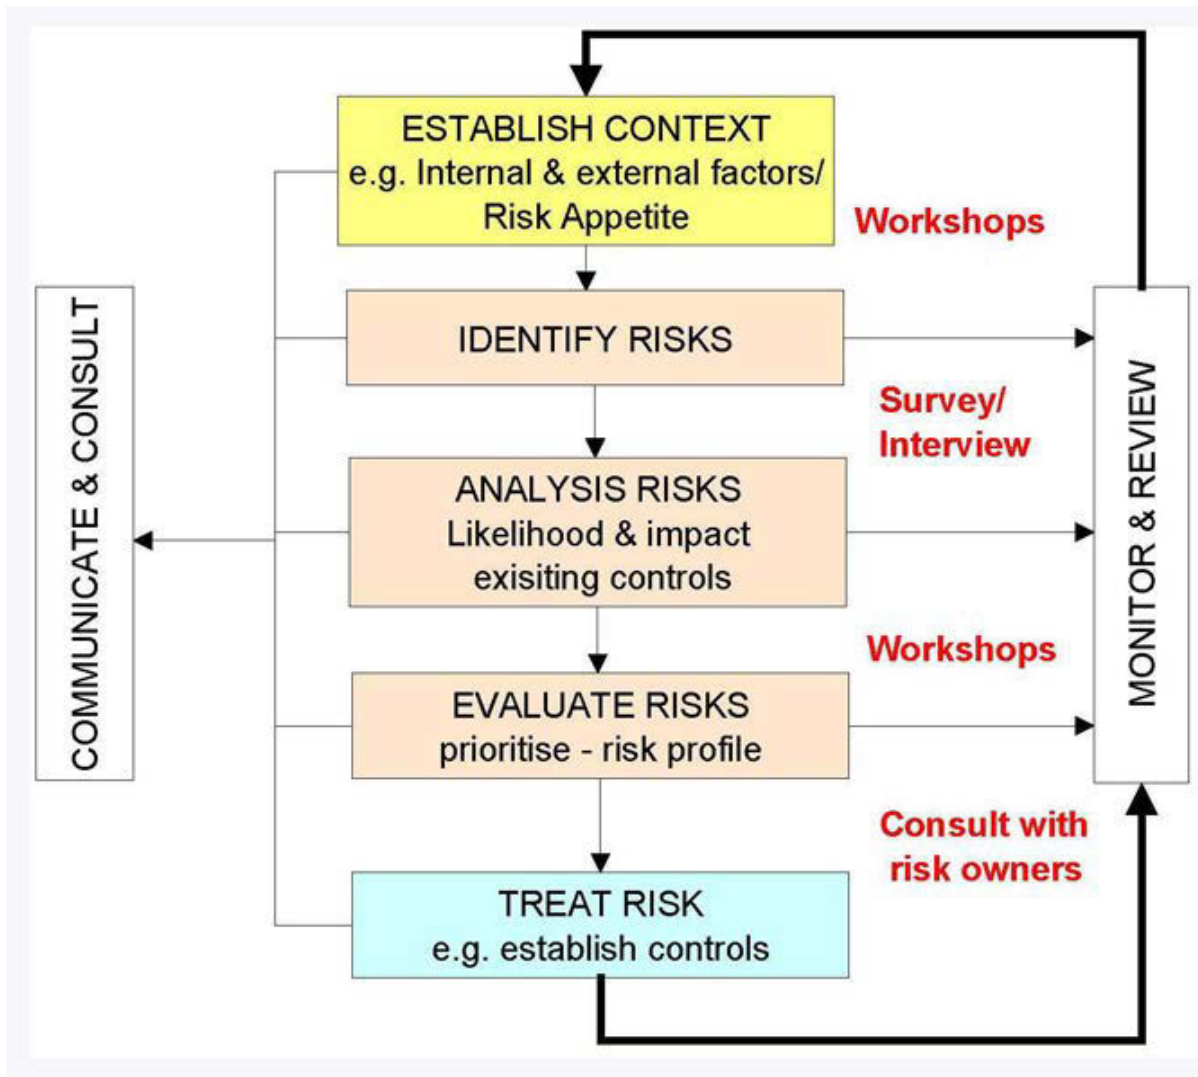
The risk-based approach requires operators to conduct risk assessments by firstly identifying all hazards present at the station platforms, analysing and quantifying the risk and making decisions on what measures and controls to take to eliminate or reduce the risks to an acceptable level. Operators and regulatory bodies have developed various risk models, but the underlying principles are the same and depicted in Figure 7: The risk management process.

**Figure 7. Risk Management Process**

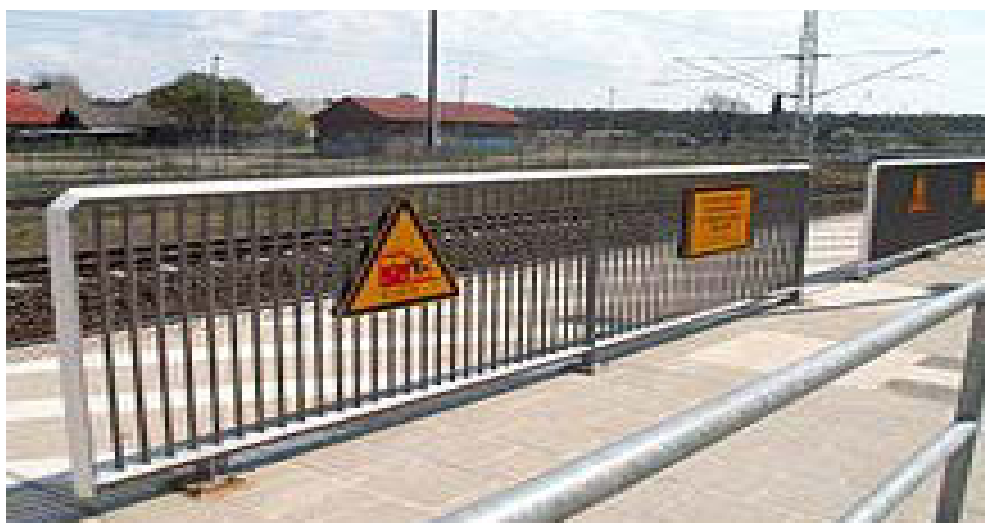
Platform barriers or fences with gates offer a quick and cost effect solution to stop passengers from being trapped between the train and platform at overcrowded stations (especially during peak periods) and to stop passengers from falling onto to the track before the train arrives. Platform barriers can be installed at stations where overcrowding has been identified as one of the risk factors. Figure 8 shows platform barrier on the Hamburg-Berlin line in Germany.

Figure 8. Platform Barrier with gates

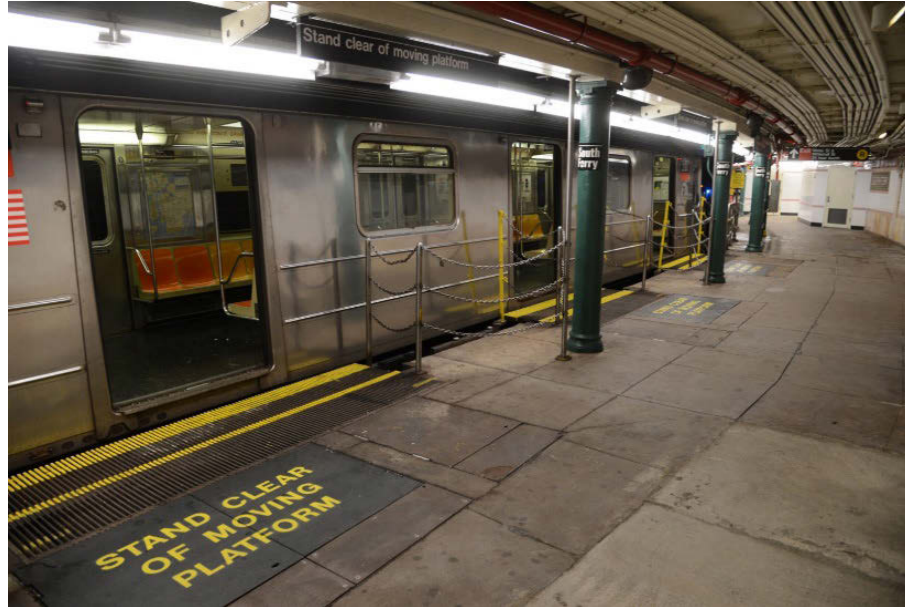
This is a more costly solution but can be deployed where the gap is excessive like on curved platforms where correction of gap by modifying the platform may not be feasible due a range of factors. Figure 9 shows a moveable platform at South Ferry New York Subway.

Figure 9. Moveable platform at South Ferry Station New York subway

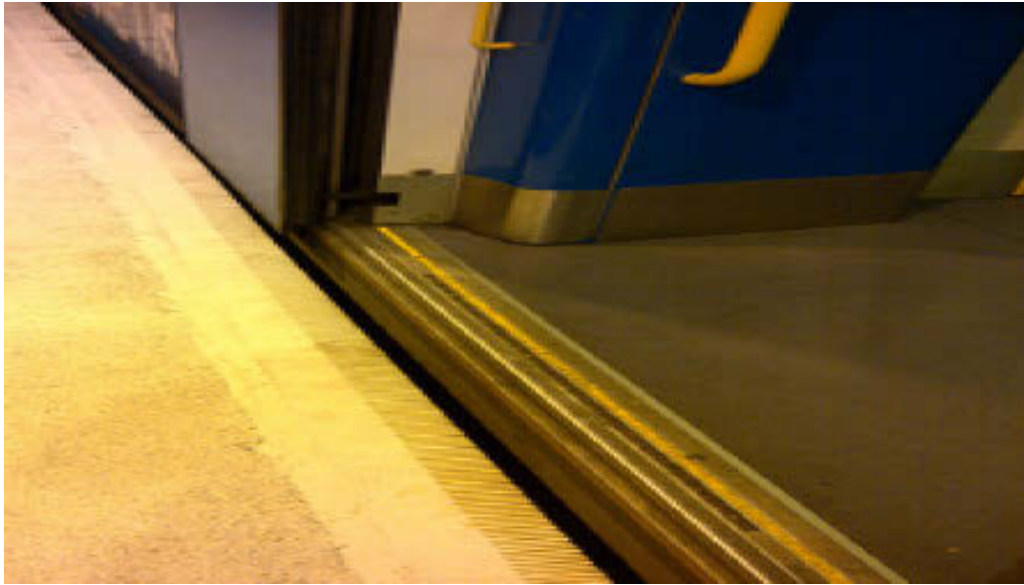
Platform gap fillers shown in Figure 10 are mounted in strips along the edge of platforms to reduce the gap between the platform and the entrance of a passenger train ensuring that when a train has stopped at a platform, passengers are able to enter and exit safely.

Platform gap fillers are strategically located along the platforms where the train car doors open and can significantly reduce the likelihood of a passenger slipping through the gap between the platform and the train. This solution, custom made by Delkor Rail Australia, is suitable for the PRASA rail system as it was developed to overcome the large differences between gap sizes at various platforms in different locations, a scenario which exist in the PRASA environment [4].

**Figure 10. Platform Gap Fillers**

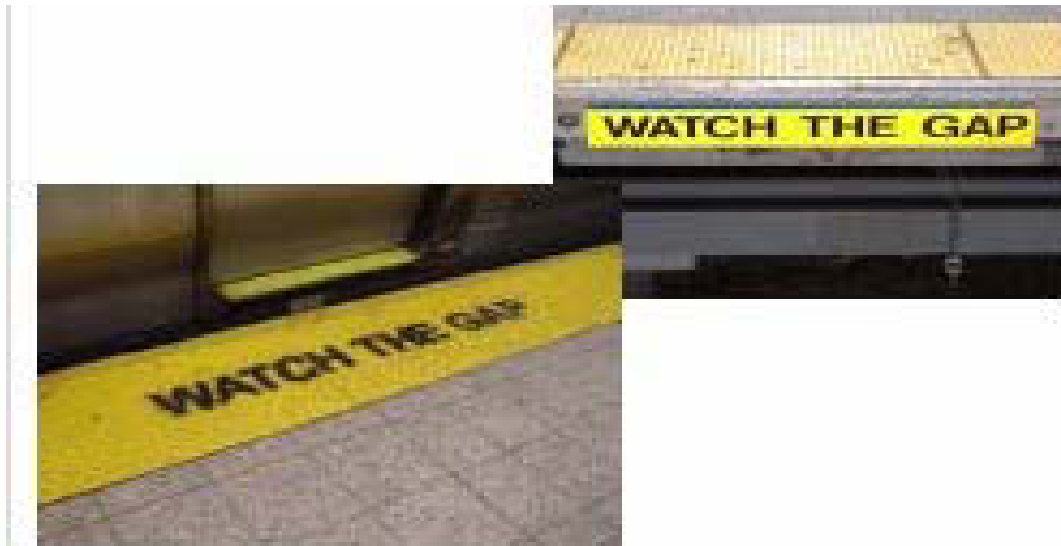
**Figure 11. Wash the gap stencils**
